# System Failure Case Studies

Volume 1 Issue 4

## SUPERCRITICAL

*In the early years of nuclear power development, the first small-scale boiling water reactor exploded catastrophically, claiming the lives of three engineering technicians. This nuclear accident occurred in January of 1961 at the U.S. National Reactor Testing Station near Idaho Falls, Idaho, and is the only nuclear accident resulting in the loss of life ever to occur in the United States. The accident, called a “prompt criticality,” resulted from a variety of factors, including inadequate design, inadequate materials testing, and poor procedures and training.*

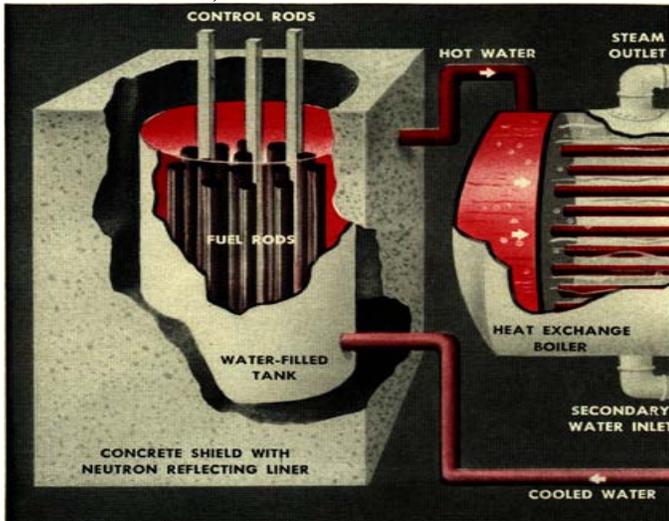
*Schematic of nuclear reactor, circa 1956.*

In a nuclear reactor, a controlled fission reaction takes place to produce large amounts of heat. A portion of this heat is removed from the reactor and is used for heating and/or electricity production. The reactor typically requires a fissionable fuel (typically isotopes of uranium), a neutron moderator (typically water), and a means of controlling the rate of reaction. A fissionable fuel is a substance with a nucleus that, upon absorption of a

thermal (low-energy) neutron, becomes unstable and “breaks apart” to form two new substances (fission products), heat, and some more neutrons. The neutrons released are of a variety of energies; however, only low-energy, or thermal, neutrons are capable of interacting with additional fuel to produce additional reactions. To convert the high-energy neutrons produced in the reaction to low-energy neutrons, a moderator is used to “slow down” the high-energy neutrons. To operate the reactor at a steady-state (also known as a critical state), a means of controlling the number of thermal neutrons that will interact with the fuel is necessary to control the fission

reaction. Control rods are devices that isolate the fuel elements and absorb neutrons. When a control rod is raised, exposing more of the fuel element to thermal neutrons, the rate of reaction increases; when it is lowered, it isolates the fuel element, and the reaction slows or stops. If control rods are not exercised correctly, an exponential unsteady state can occur by either increasing (also known as a supercritical state) or decreasing (also known as a subcritical state) the rate of nuclear reaction.

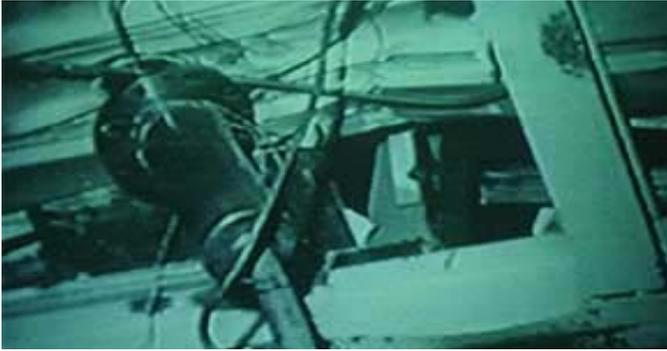
*Control rod lodged in ceiling of SL-1 reactor building.*

The SL-1 reactor accident was initiated by the withdrawal of its central control rod to a level of approximately 20 inches in the space of 0.5 seconds. Starting from a fully shutdown condition, the action produced a condition in the core technically known as a “prompt criticality,” also known as a supercritical state without the contribution of delayed neutrons emitted after fission has occurred.

Insufficient Testing of New Technology: The reason behind the occasionally sticking control rods has never been officially determined. However, it is quite possible that the BPSs that had been tack welded to the fuel assemblies had deteriorated. The burnable poison was an aluminum/boron alloy that had a relatively low melting point, and was relatively soft. The tack welds may have failed. Any deformation of these strips could have resulted in the observed sticking.
